5. Problem: Minor repairs

Minor repairs are not required only in old structures, which may demand maintenance, but also in new ones, due to wrong choice of materials or bad application. Below are some of the most common problems that can appear in a structure.

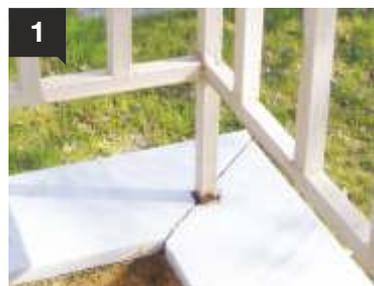
1
The influence of water resulted in the rusting of the base of the railing, a situation that needs to be confronted immediately, as it makes the whole construction dangerous.

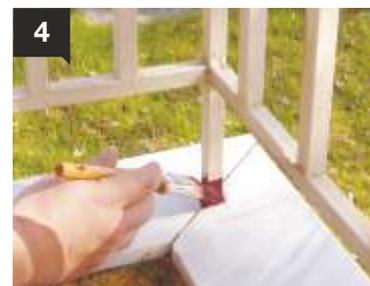
4
If the railing is not destroyed from the rust and its replacement is not necessary, it is primed with **ISOLAC RUST PRIMER**.

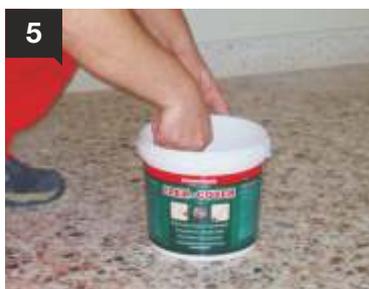
5
FLEX-COVER is prepared: A-component is added into B-component under continuous stirring.

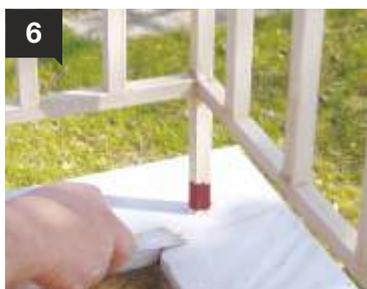
6
The surface is slightly dampened and **FLEX-COVER** is applied on the joint with a putty knife.

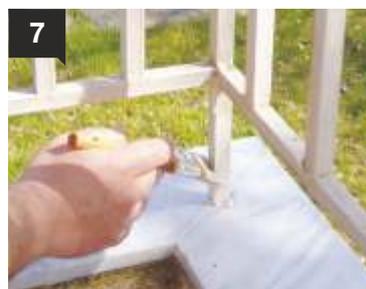
7
Finally, after **FLEX-COVER** has dried, the railing is painted with **ISOLAC DUCO**.

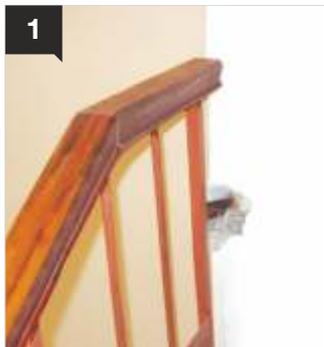
Fixing rails into the wall is an application that requires speed and great stability.

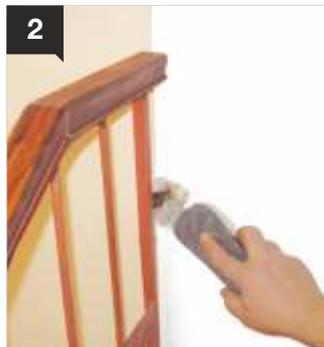
Firstly, the surface is cleaned of any dust, etc.

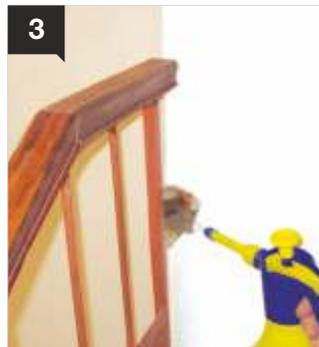
Subsequently, the surface is thoroughly dampened.

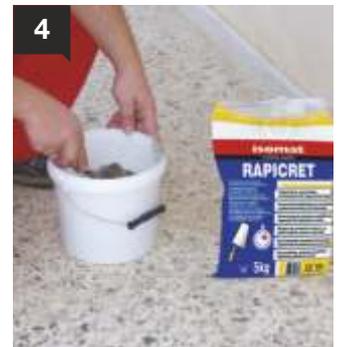
RAPICRET is added into water under continuous stirring, until a mixture of the desired workability is formed.

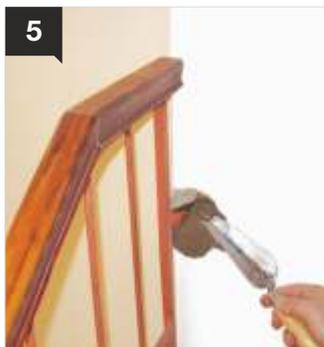
The material is applied by pressure using a trowel, as usual.

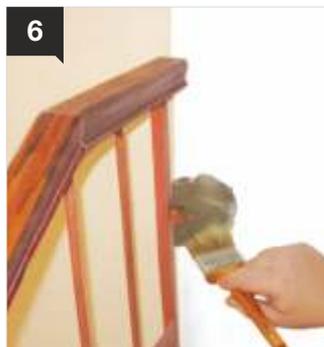
Subsequently, the surface is smoothed with a moist brush.

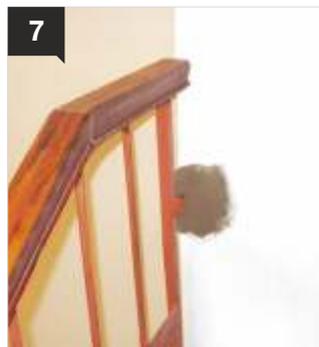
RAPICRET starts to harden after 15 min. and the rail is almost stabilized.

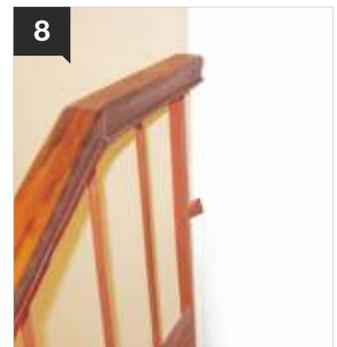
The next day, the surface is ready to be painted with **ISOMAT CLASSIC**.
